DEPARTMENT OF TRANSPORTATION

Contract #: 04-0120F4Cty: SF/ALA Rte: 80 PM: 13.2/13.9File #: 69.28**WELDING INSPECTION REPORT****Resident Engineer:**Pursell, Gary**Address:** 333 Burma Road**City:** Oakland, CA 94607**Report No:** WIR-001506**Date Inspected:** 10-Feb-2008**Project Name:** SAS Superstructure**OSM Arrival Time:** 700**Prime Contractor:** American Bridge/Fluor Enterprises, a JV**OSM Departure Time:** 1500**Contractor:** Zhenhua Port Machinery Company, Ltd (ZPMC), Changxing Island **Location:** Shanghai, China

WELDING INSPECTION REPORT

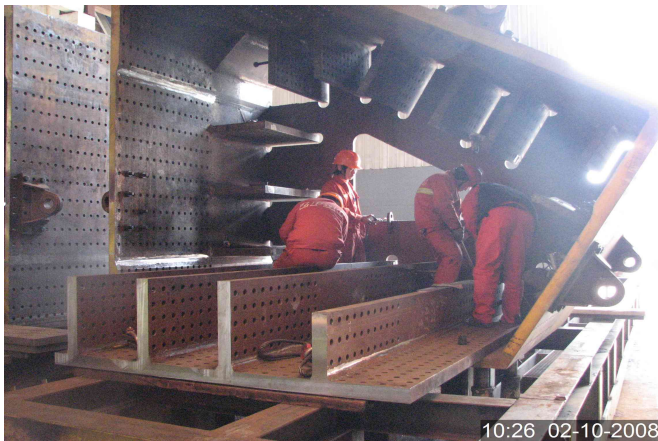
Bay 2

The Quality Assurance Inspector observed ZPMC performing fit-up operations of an internal bolted connection at skin plate A. Below is a digital photograph illustrating the fit-up in progress.
